DEPARTMENT OF NATURAL RESOURCES
DIVISION OF OIL, GAS AND MINING

RE: Site Inspection, Robert Clark, Emeryide Mine, S/015/053, Emery County, Utah

Date of Inspection: September 26, 2002
Time of Inspection: 2:00 to 3:30 p.m.
Conditions: Mostly clear, 70's
Participants: Jeff McKenzie, BLM; Paul Baker, DOGM

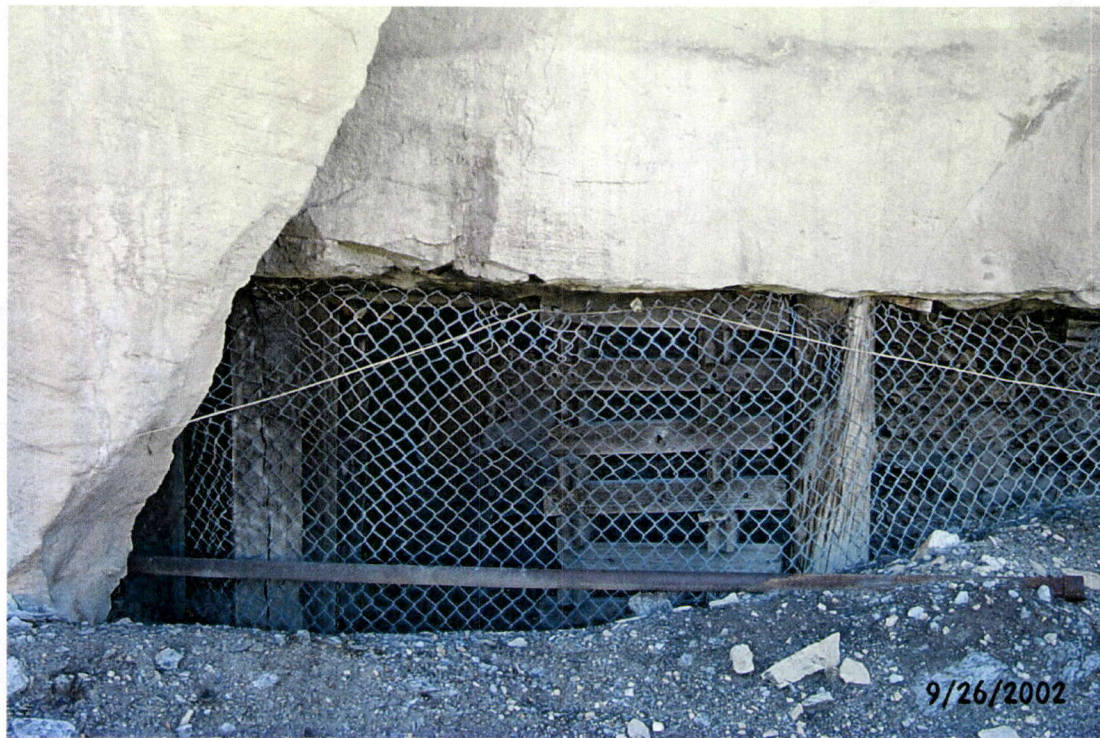
I believe the entrance and portal shown in Photos 1 and 2 are part of Robert Clark's operation. One portal is fenced, and the other has a locked gate that has now been repaired so it would be impossible to enter without tearing down part of the fence or gate.

In May, the BLM representatives noticed some rocks that appeared to be breaking off from above the fenced portal (Photo 1). I had not known what this comment was referring to, but Mr. McKenzie showed me an area where about three or four large blocks of sandstone have rotated outward and appear to be on the verge of falling. (Unfortunately, I did not photograph this area.) If these were to fall, they would endanger anyone on the portal pad and would probably also roll to the county road below.

Photo 1. Fenced opening--not truly a portal.

The rocks above the portal in Photo 1 appear to create a safety hazard both for miners and for the public. The operator needs to closely evaluate this situation and may want to hire a specialist to determine whether anything needs to be done to either stabilize these rocks or to intentionally cause them to fall. If the operator causes them to fall, it will be necessary to coordinate this with the county sheriff to ensure no one is on the road.

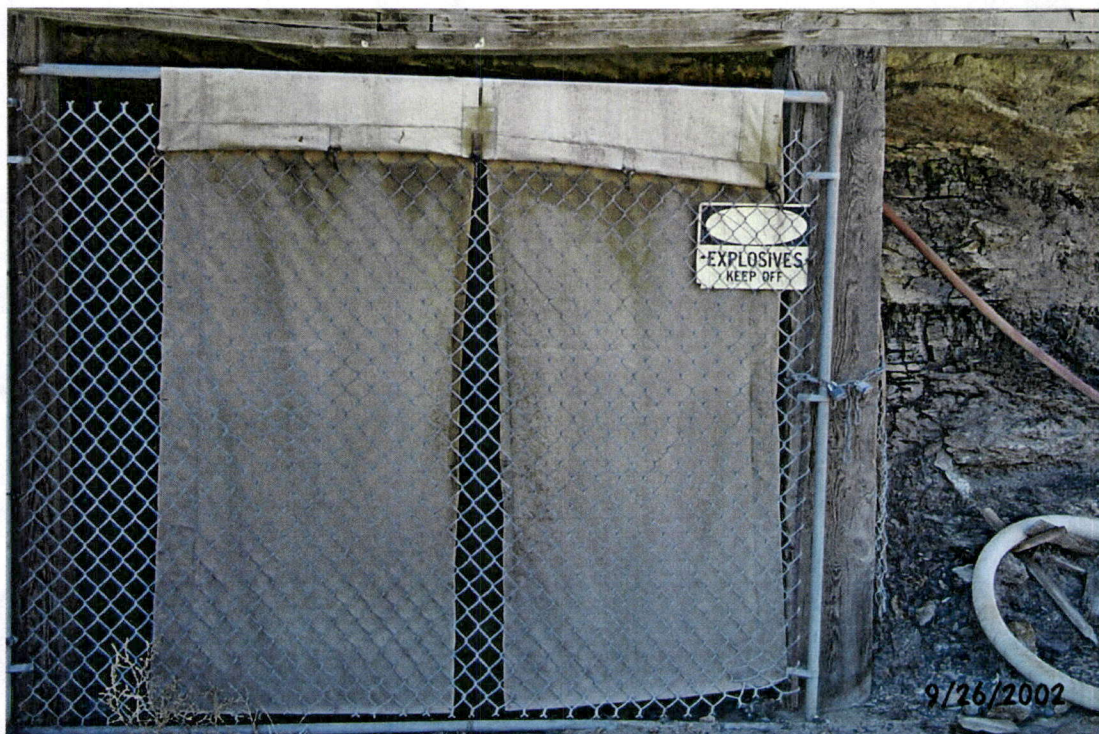
Photo 2. Second portal.

To remove any questions about the wire leading into the portals, it should either be removed or coiled and put in the portals.

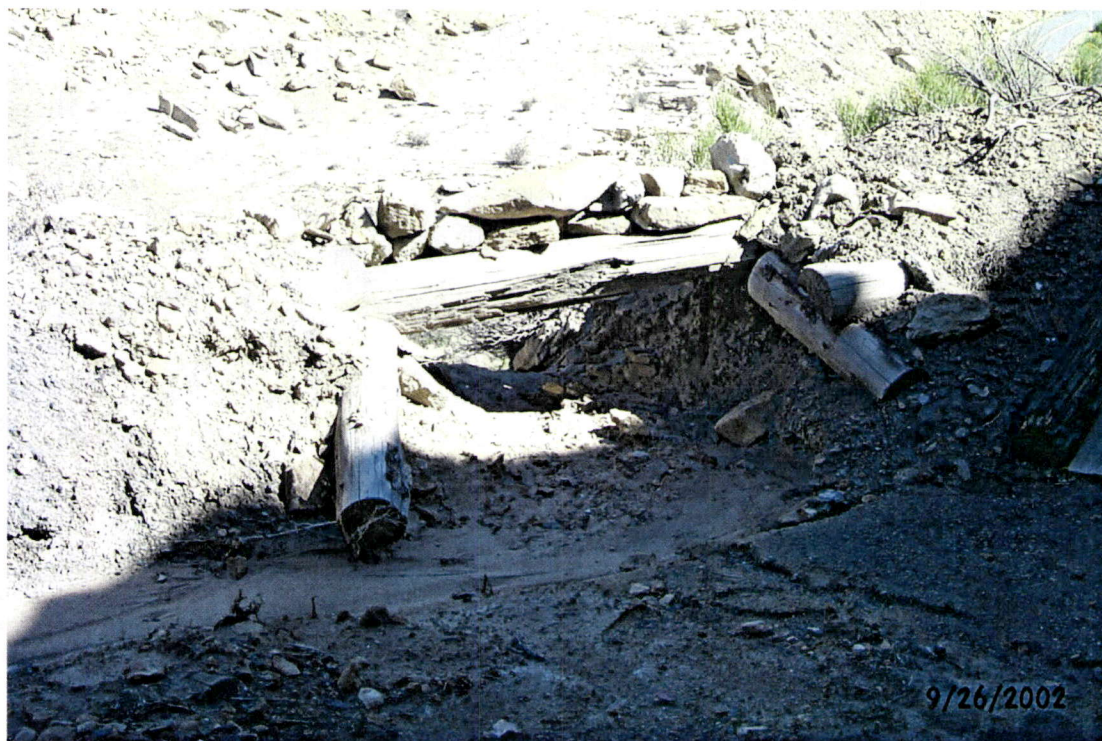
The berm on the pad outslope is breached, and the operator has put rocks and logs around this breach in an apparent attempt to stabilize it (Photo 3). There is some sediment leaving the site through this breach.

Photo 3. Breached berm.

There is little that can be done about water flowing uncontrolled over the outslope because the pad was not intended to be an impoundment and water needs to be able to leave the site. The operator should find a place where the pad outslope is already self-armored—possibly the slope below the existing breach—and install a notched silt fence at the breach. This would treat water from the mine site and reduce the amount of additional sediment being eroded from the hill.

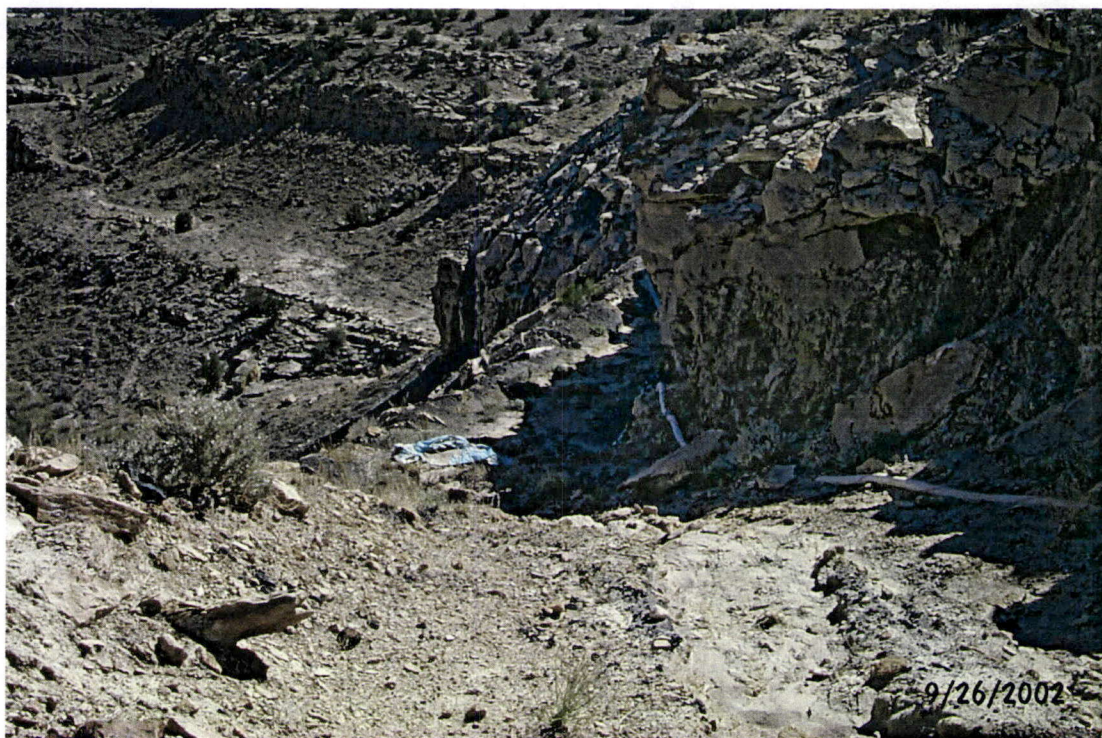
As one travels north from the portals toward the middle bench, there are some hoses and brattice that need to be cleaned up (Photo 4). Toward the top, there is a pile of what appears to be mine waste. It looks like this was in plastic bags and dumped here (Photo 5).

Photo 4. Hoses (mostly in the shadow to the right) and brattice that should be cleaned up.

The operator should clean up the hoses, brattice cloth, and mine waste and the car battery if this is the operator's responsibility. Ideally, the barrels would be stored in a rubber lined concrete facility, but for this operation, it would be acceptable to have a lined earthen pit.

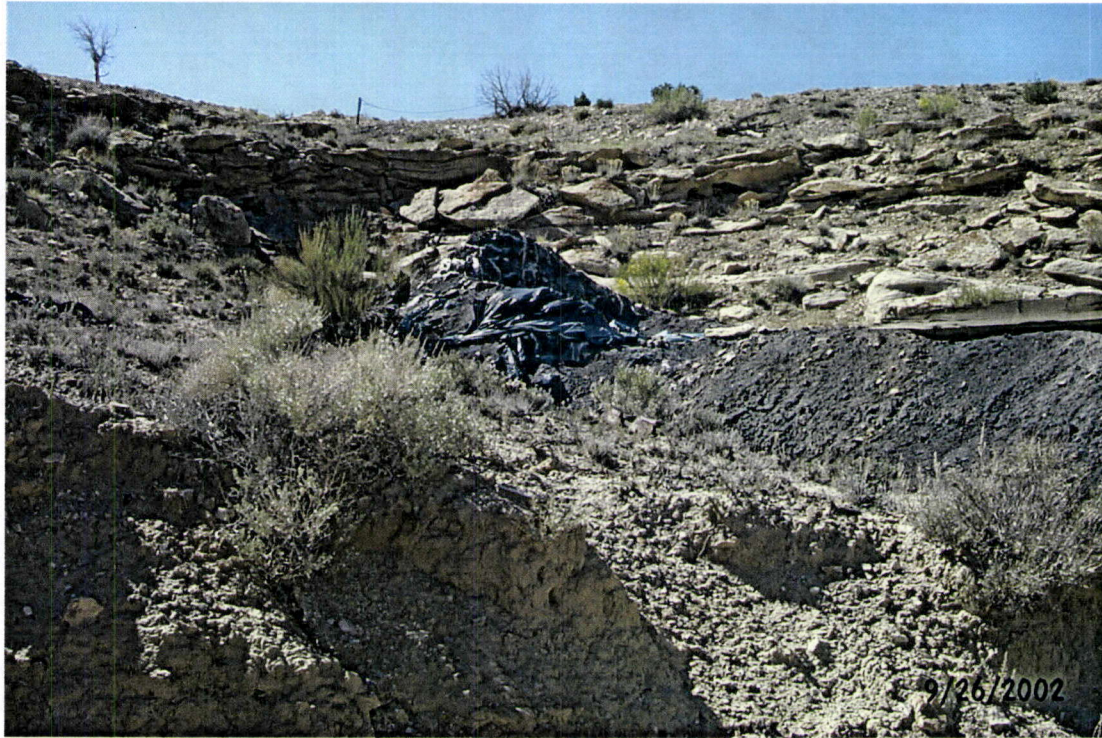
Photo 5. Mine waste that should be cleaned up. Note the plastic garbage bags near the center of the photo.
